HUDSON RIVER BASIN  
TRIBUTARY OF WALLKILL RIVER  
SUSSEX COUNTY  
NEW JERSEY

# MORRIS LAKE DAM

## NJ 00306

### PHASE 1 INSPECTION REPORT NATIONAL DAM SAFETY PROGRAM

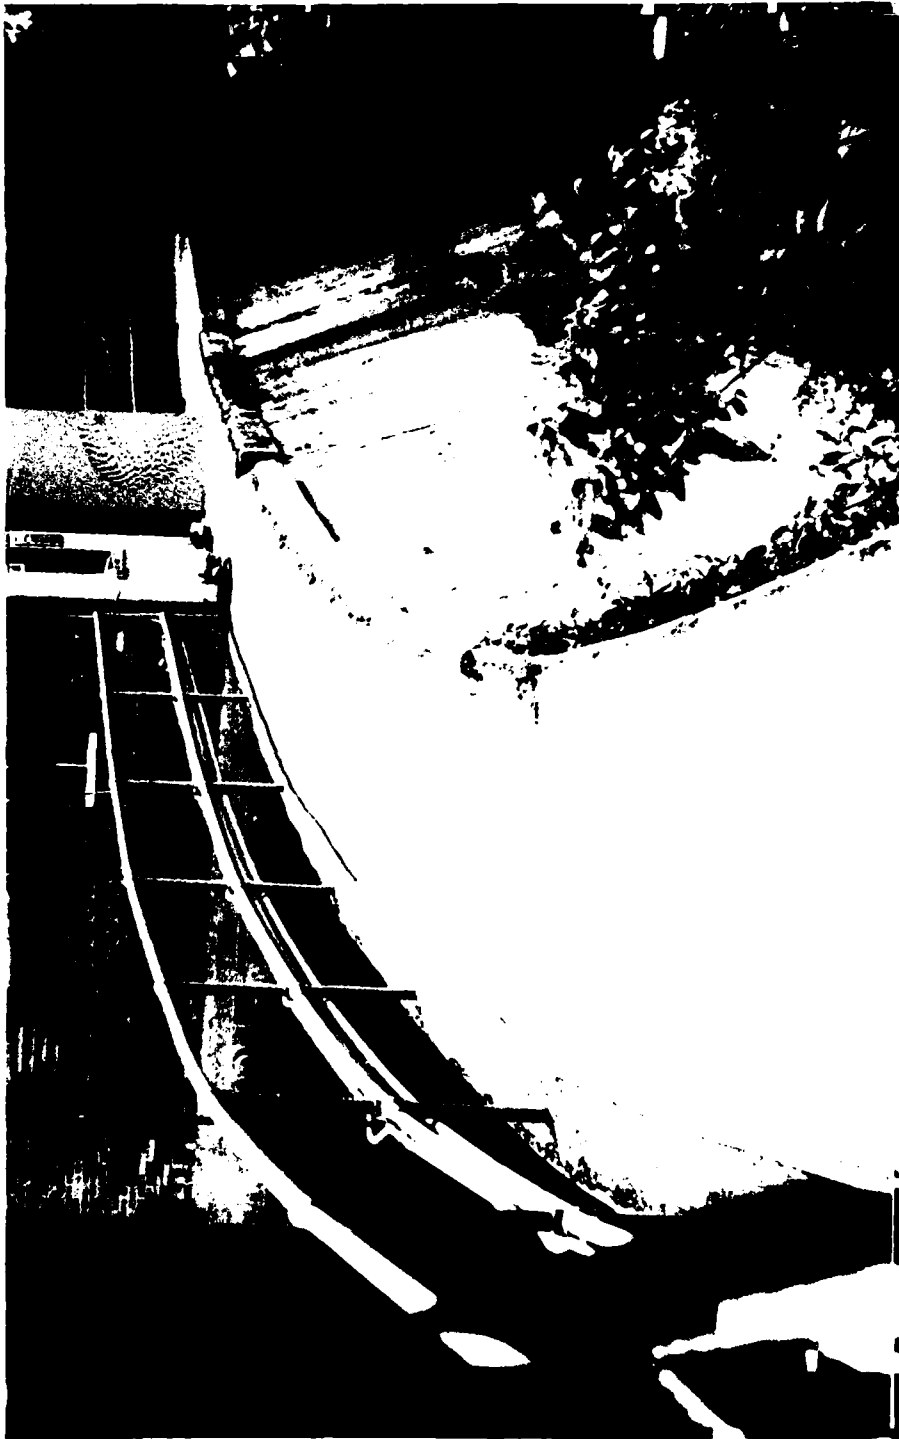
OVERALL VIEW  
MORRIS LAKE DAM

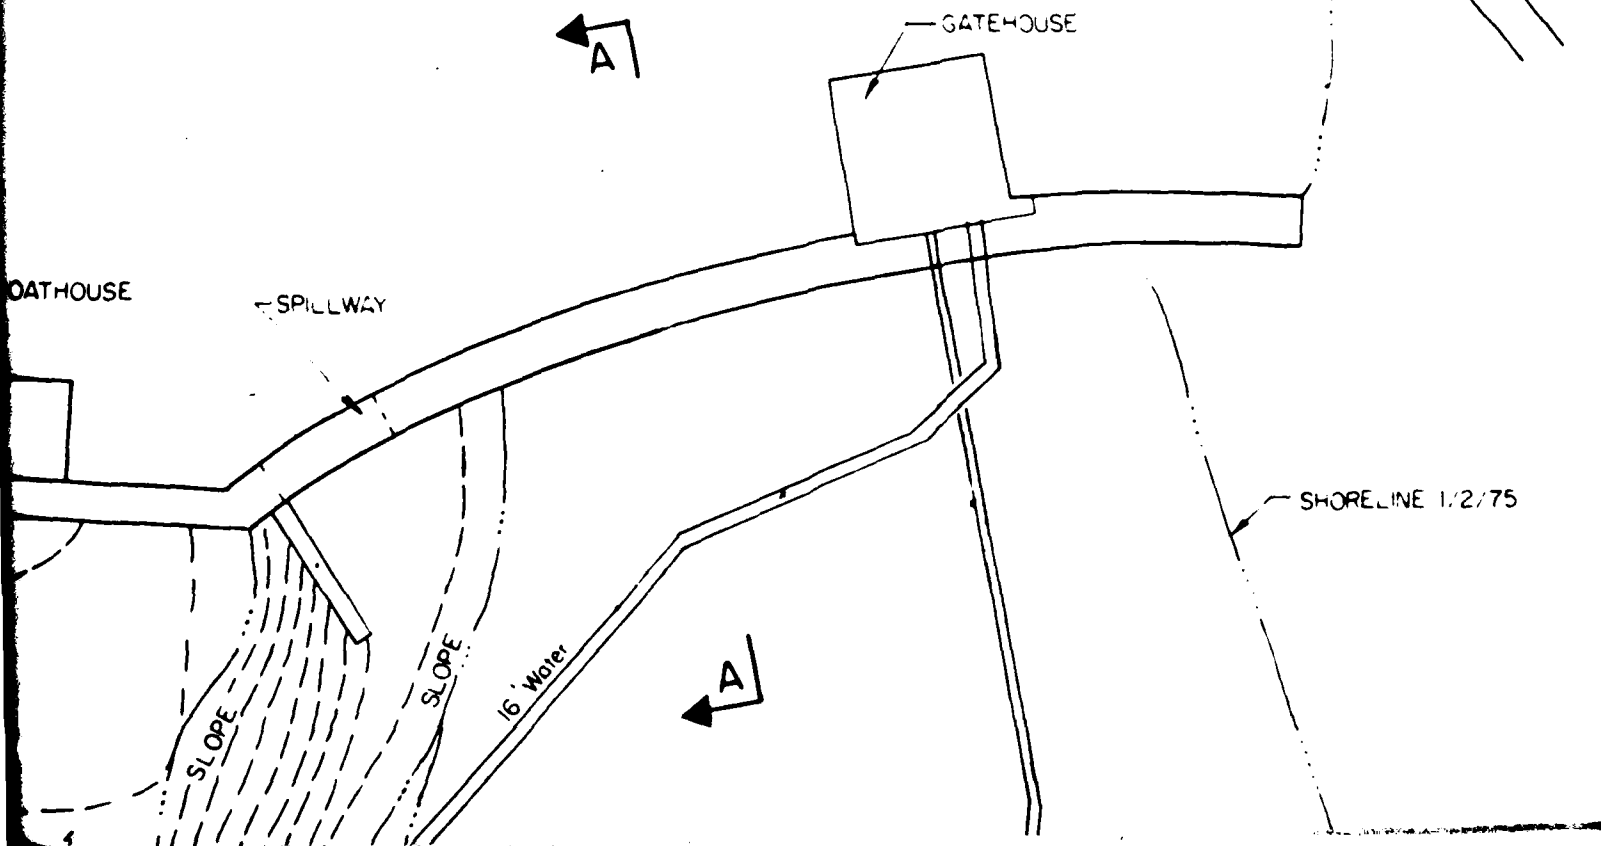
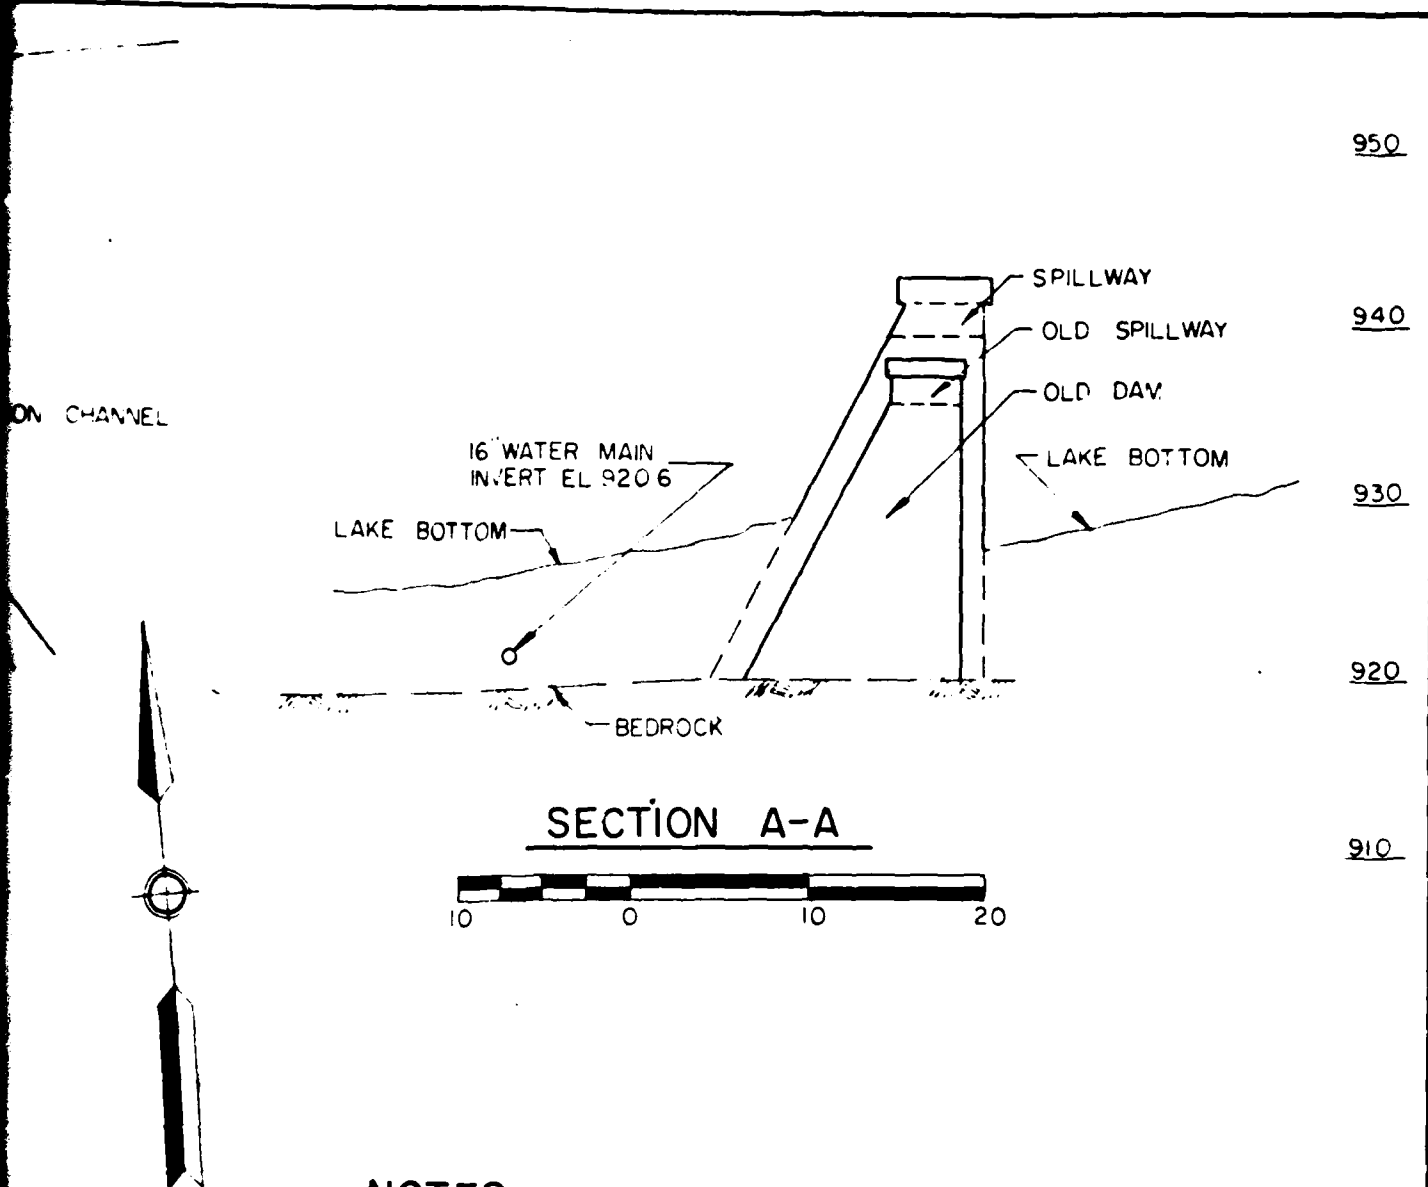
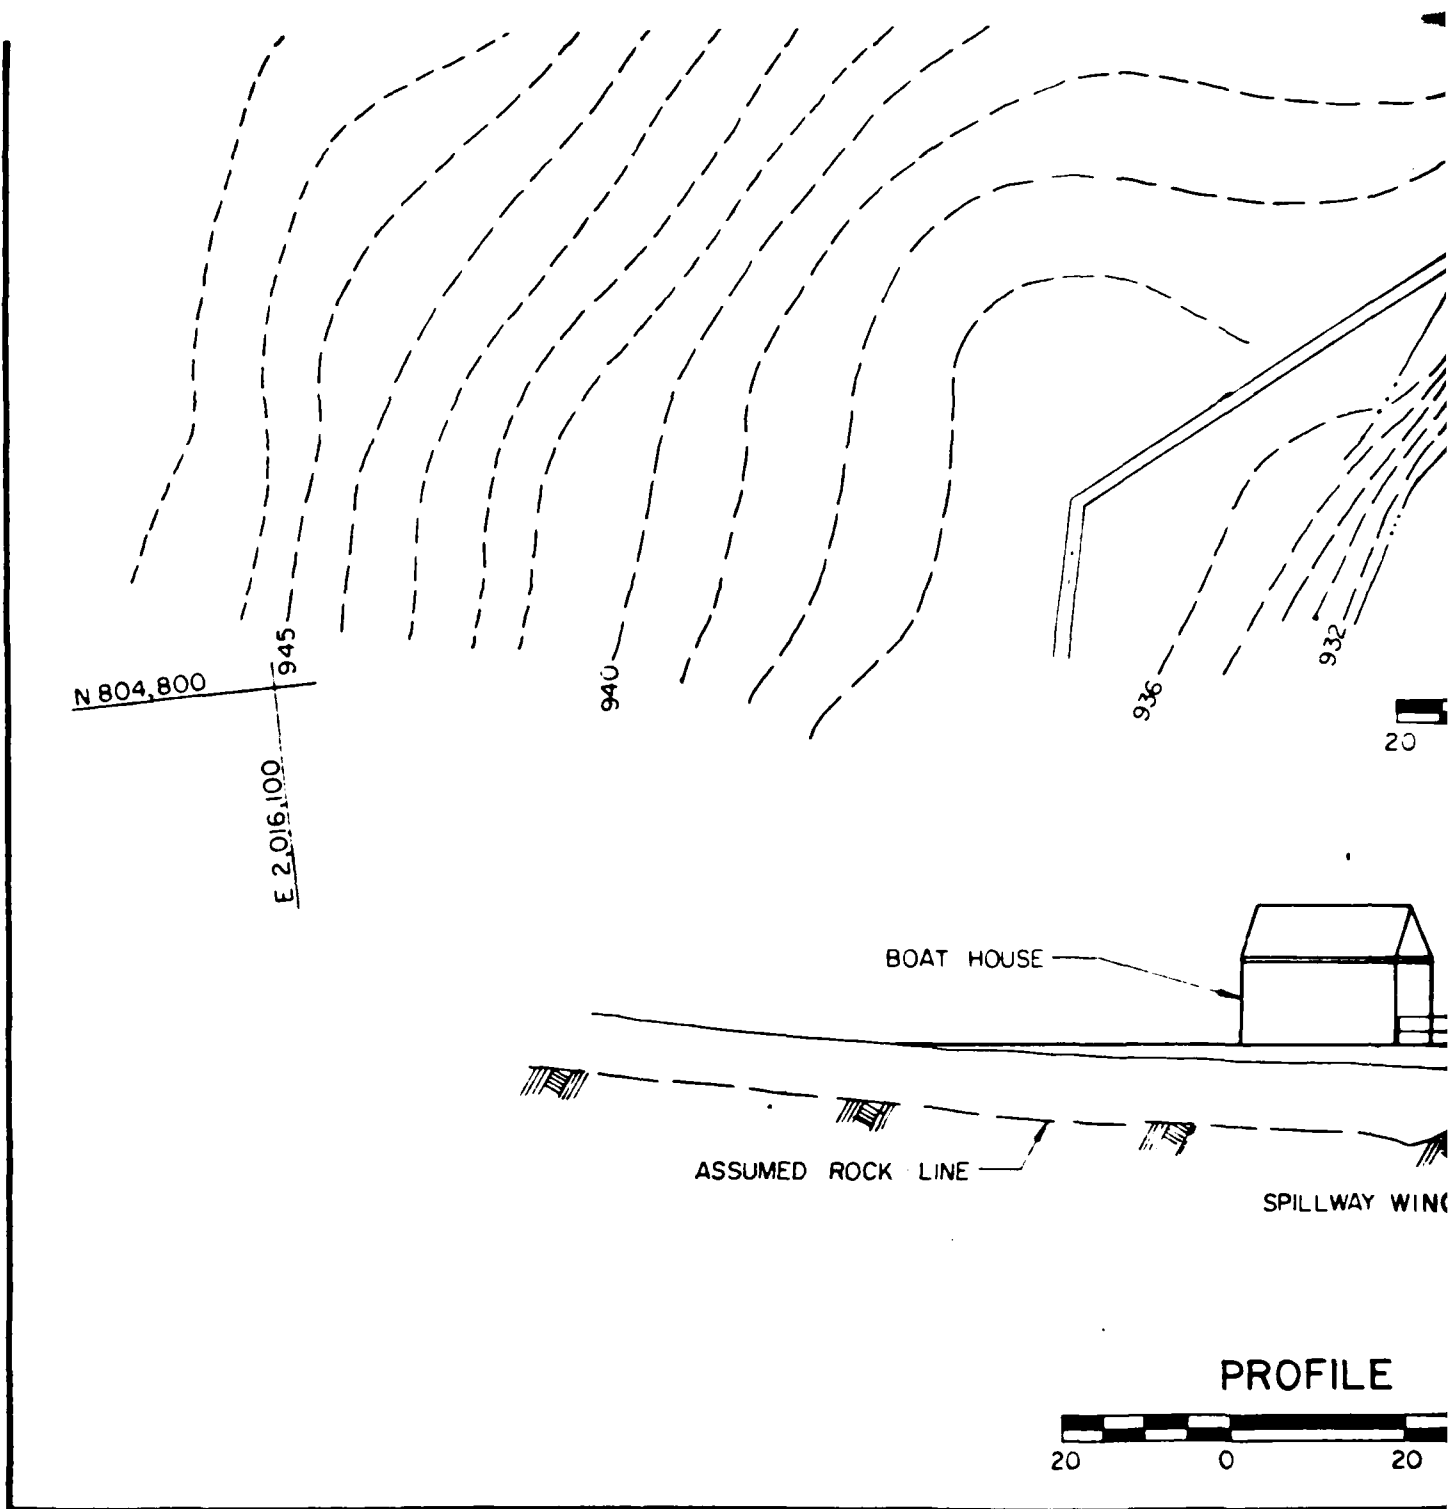
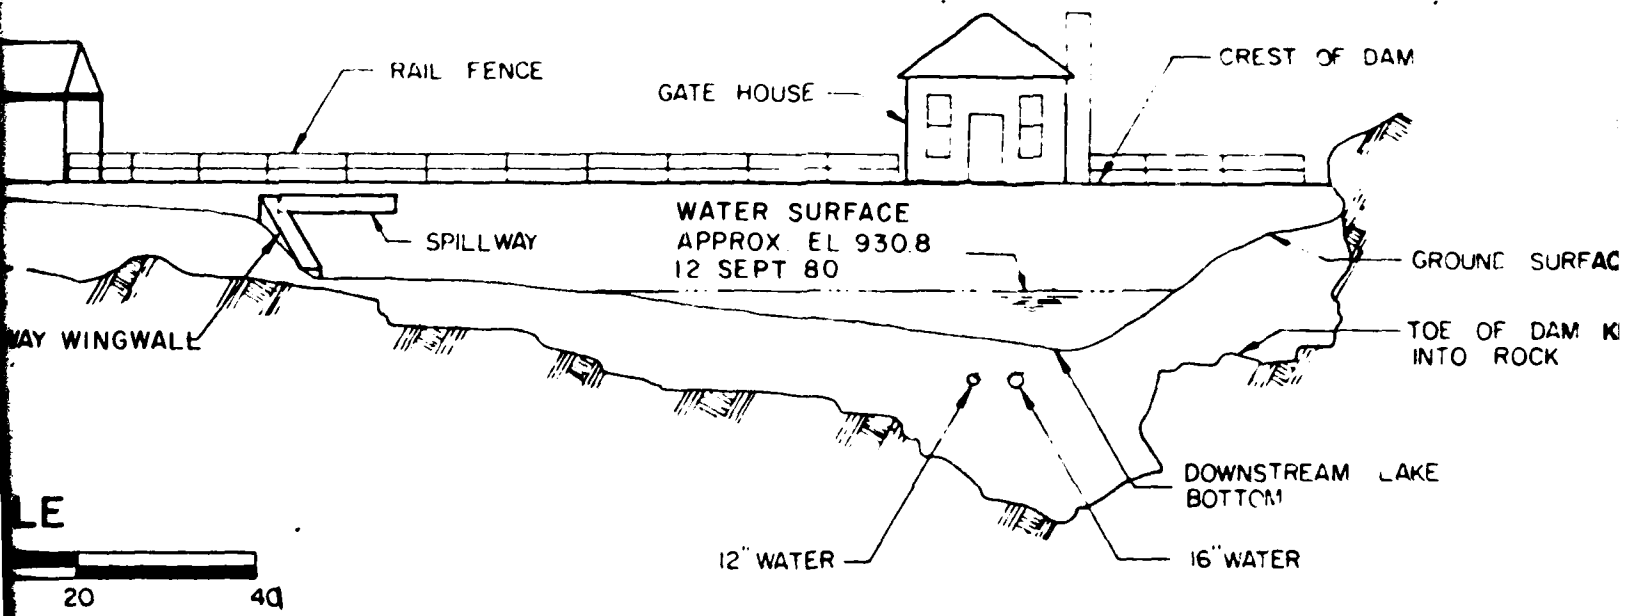
1. THIS PLAN WAS ADAPTED FROM DRAWING PREPARED BY  
CAHN ENGINEERS, INC., WALLINGFORD, CONNECTICUT, MORRIS  
LAKE DAM, DAM PLAN, PROFILE & SECTION, MARCH 1979

2. THIS PLAN WAS COMPILED FROM RECORD DRAWINGS FOR THE INSTALLATION OF "WATER TRANSMISSION MAIN REINFORCEMENT" BY CAHN ENGINEERS INC DATED AUGUST 1976 AND FROM NOTES ON NEWTON, NJ WATER WORKS CONSTRUCTION AND LITIGATION, BY LL TRIBUS, JUNE 1909

3 LOCATION OF CONCRETE FACING OVER OLD DAM, SHOWN IN SECTION A-A IS ESTIMATED AND MAY VARY

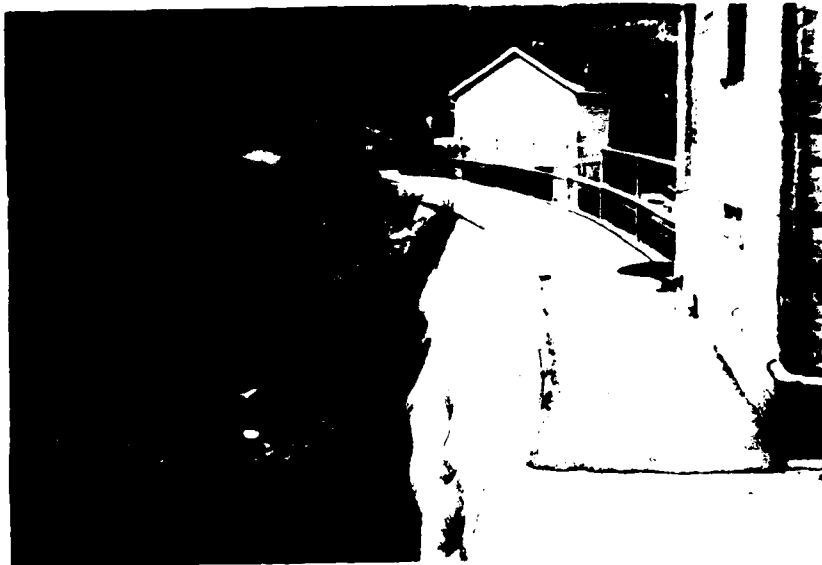
Morris Lake Dam is in fair overall condition. The gunite facing on the downstream face of the dam has numerous large cracks. The gunite surface below the cracks appears to have separated from the body of the dam. Weeds are growing in many of these cracks. There is limited seepage from a crack in the gunite surface approx 10' below the top of the dam in the area of the gatehouse. There are bulges in the gunite surface on the downstream face at the water line. The upstream face of the dam, where visible, has occasional areas of spalling and cracking of the gunite surface. The concrete forming the east abutment is spalled and deteriorating on the upstream face. The concrete downstream wingwall on the west side of the spillway is extensively spalled and deteriorated.

VISUAL EXAMINATION OF	OBSERVATIONS	REMARKS OR RECOMMENDATIONS
SURFACE CRACKS CONCRETE SURFACES	NUMEROUS CRACKS AND SPALLING OF CONCRETE (GUNITED) FACING ALONG UPSTREAM & DOWNSTREAM FACE. GRASS GROWING OUT OF MANY CRACKS ON THE DOWNSTREAM FACE.	INVESTIGATE EXTENT OF DETERIORATION. REPAIR IF NECESSARY.
STRUCTURAL CRACKING	NONE OBSERVED.	
VERTICAL AND HORIZONTAL ALIGNMENT	VERTICAL - ARCHED UPSTREAM HORIZONTAL - LEVEL	
MONOLITH JOINTS	SPILLWAY APPEARED TIGHT, NO SIGNS OF LEAKAGE.	
CONSTRUCTION JOINTS	APPEARED TIGHT, NO SIGNS OF LEAKAGE.

Downstream face of dam. Looking  
west from east side of dam.

1. Investigate the cause of cracking and separation and repair the facing on the downstream side of the dam.
2. Establish a warning system and develop written operating procedures and a periodic maintenance plan to ensure the safety of the dam.
3. The spillway capacity is estimated to be inadequate. The capacity of the spillway and SDF should be determined using more precise and sophisticated methods and procedures.

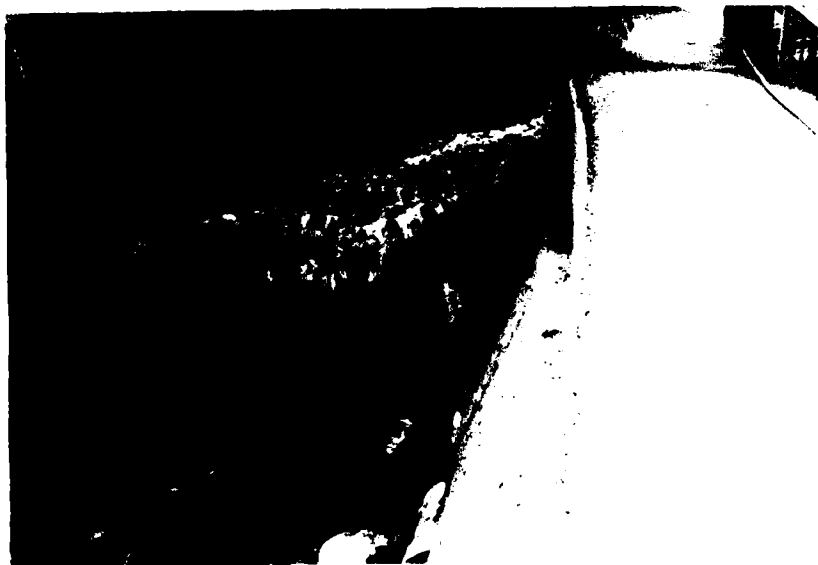
Downstream wing wall west of  
spillway and discharge channel.

1. Perform additional investigation to determine seepage conditions through and under the dam, the engineering properties of the dam and foundation, and whether or not conventional safety margins exist under more severe stress conditions than those observed during our inspection, and, what modifications may be required to achieve such safety margins.
2. Provide emergency low level outlets for the dam.
3. Repair areas of spalled and deteriorated concrete on the dam appurtenances.

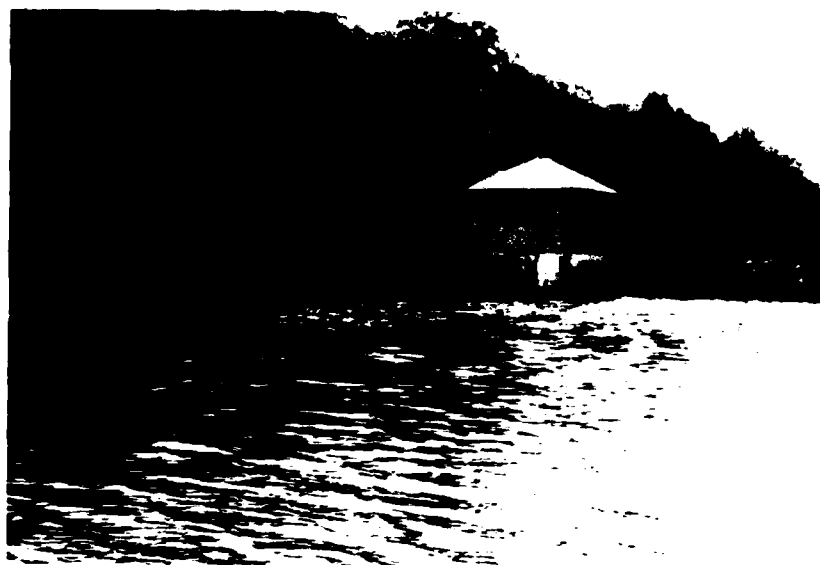
The gatehouse appears in good general condition with all equipment reported in operable condition.

Upstream face of dam, east side,  
showing east abutment and gate house.

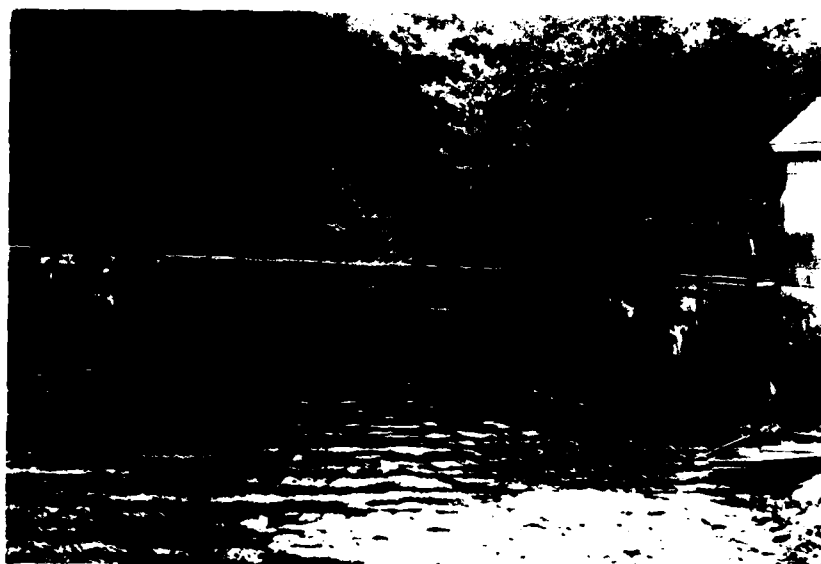
VISUAL EXAMINATION OF	OBSERVATIONS	REMARKS OR RECOMMENDATIONS
CONCRETE WEIR	NO APPARENT DEFECTS OBSERVED.	
APPROACH CHANNEL	NONE - UNOBSTRUCTED	
DISCHARGE CHANNEL	NATURAL ROCK OUTCROP TO GLEN LAKE IMMEDIATELY DOWNSTREAM OF DAM. BRUSH GROWING IN CHANNEL.	REMOVE BRUSH.
BRIDGE AND PIERS	FOOT PATH STRUCTURE SPANS OVER SPILLWAY TO FORM FOOT BRIDGE. NO APPARENT DEFECTS OBSERVED.

Upstream face of dam, west side,  
showing spillway opening.

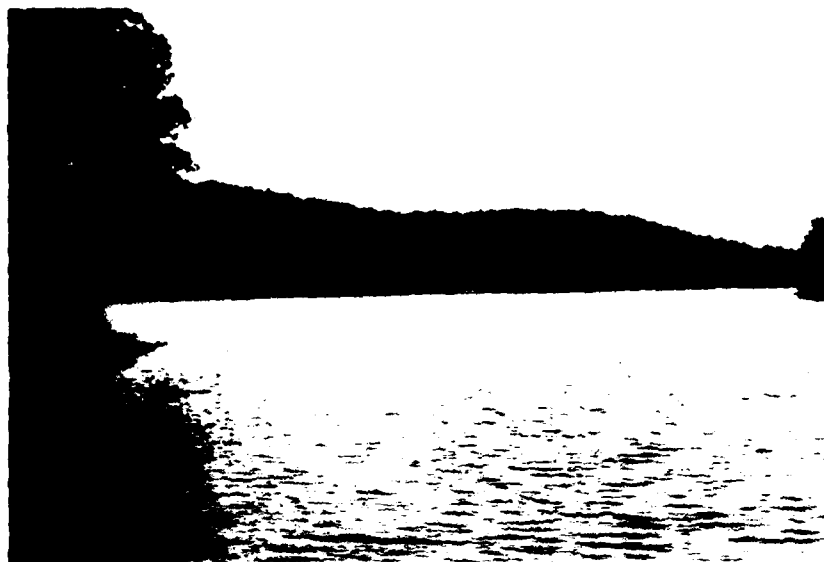
VISUAL EXAMINATION OF	OBSERVATIONS	REMARKS OR RECOMMENDATIONS
SLOPES	APPROX 2H: 1 VERTICAL - ROCK OUTCROPS RIPRAP APPEARS EVEN & WELL PLACED AROUND SHORELINE VISIBLE FROM D.M.	
SEDIMENTATION	NONE OBSERVED WITH THE EXCEPTION OF SLIGHT BOTTOM GROWTH.

West shoreline of Reservoir viewed  
from center of dam

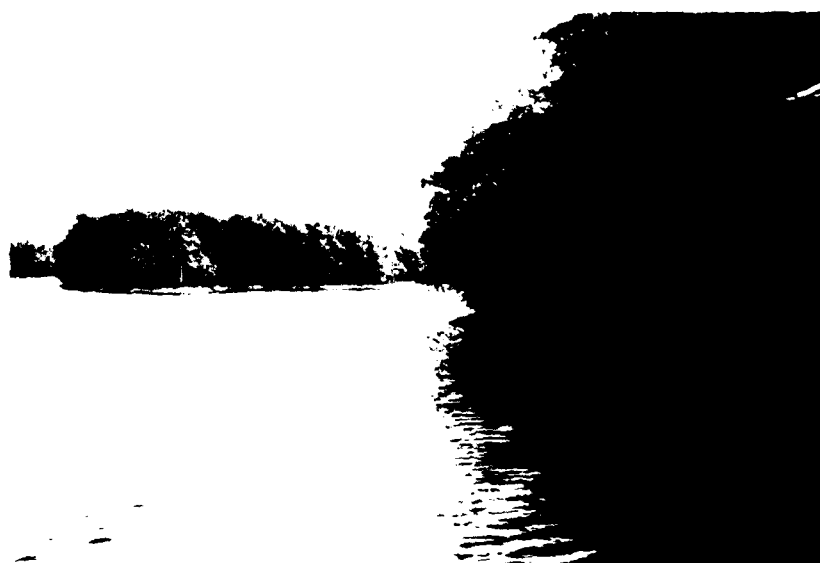
East shoreline of Reservoir viewed  
from center of dam.

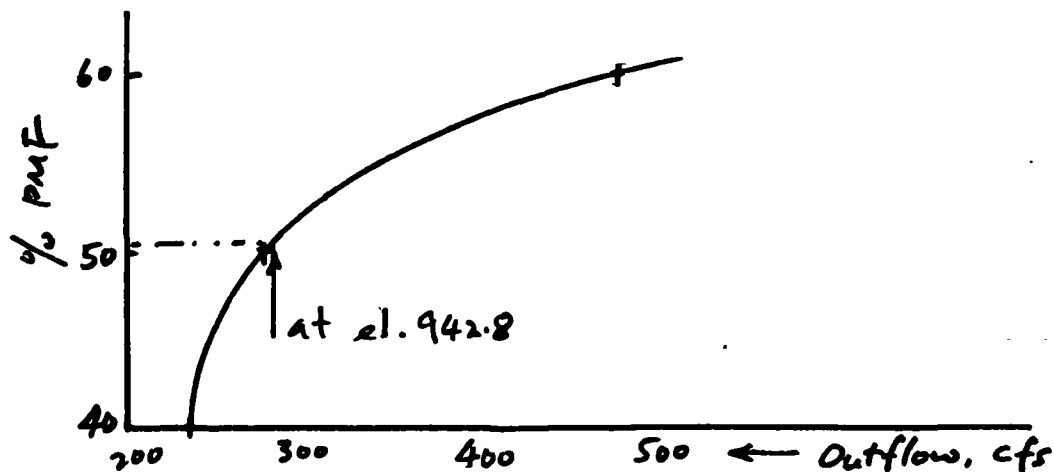
- 1) Various % of PMF have been routed using HEC-1 DB
- 2) Plot peak outflow vs % PMF

- 3) Dam overtops at elev. 942.8 with  $Q = 283$  cfs  
 $\therefore$  dam can pass approx. 50 % of PMF

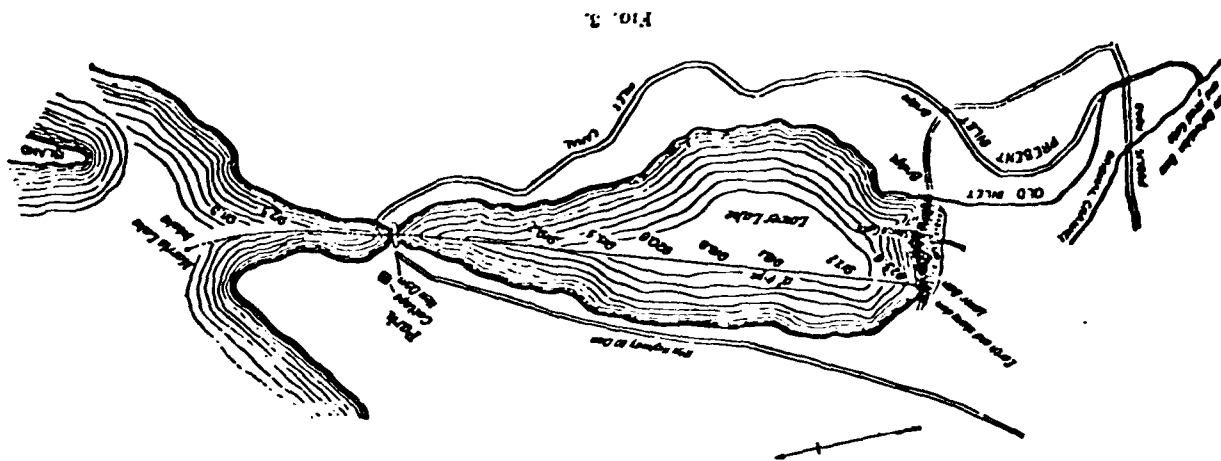
Fig. 3 shows the general plan of headgate, canal, pond, lake, standpipe, and submerged outlet conduit.

The head-gate works for controlling the diversion canal consist of a small masonry dam and overflow weir, having two 24-inch gates opening into the canal. These openings will pass all of the normal and much of the flood season flow of the stream, and are located on Pine Swamp Brook about three thousand feet from and fourteen feet above the upper lake.
